# Amerton News

### Permanent Way

### Locomotives

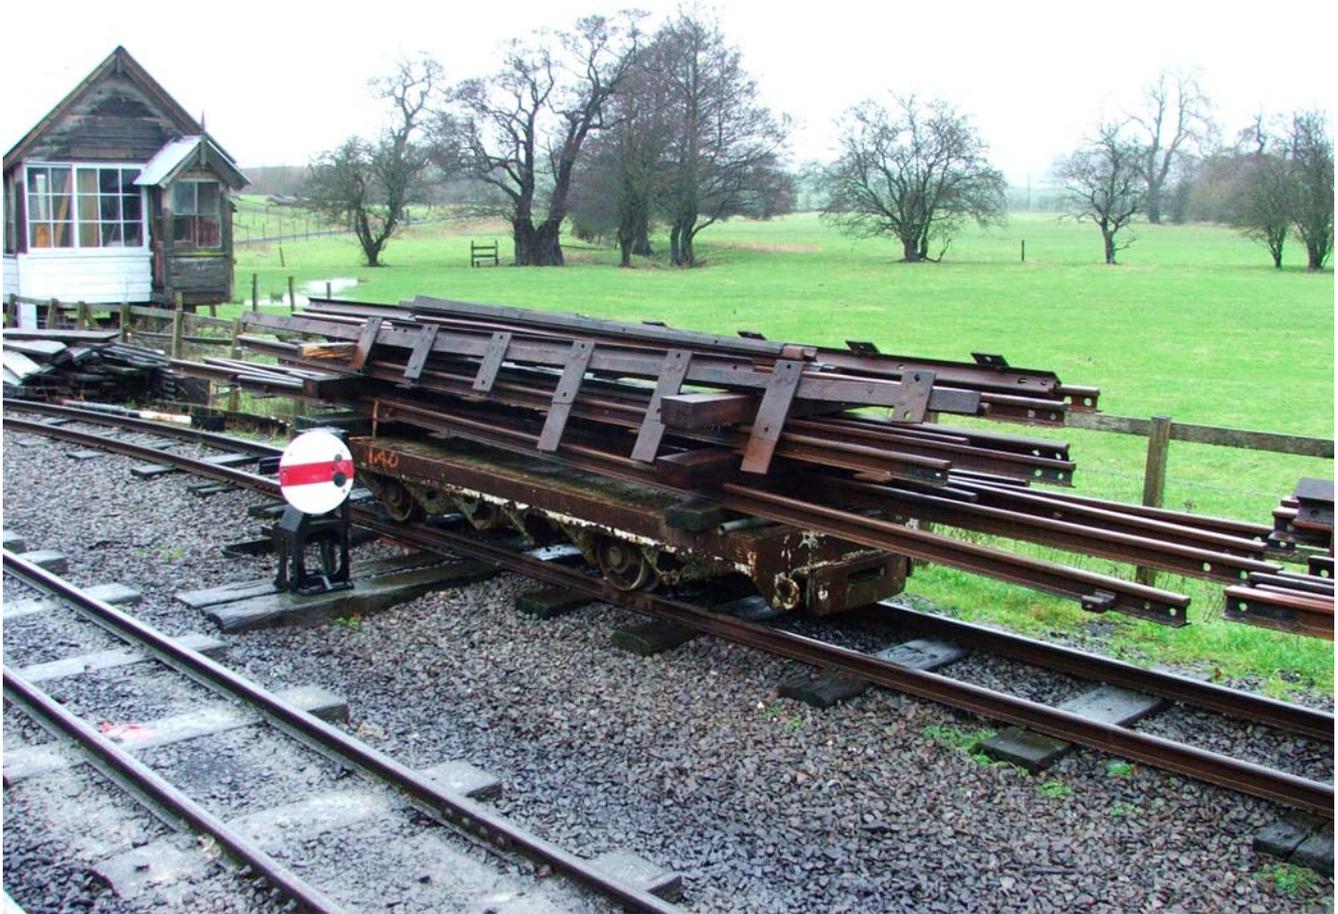
*The stored VoR rail in the loop at Amerton, these are the parts of the two turnouts!*

Two 12ft 35M panels were made up from materials in stock including heavy-duty steel sleepers, ready for *Isabel* to be moved and displayed at the Stafford show. The VoR rail was still to be moved out of the loop and be stored at Chartley Road.

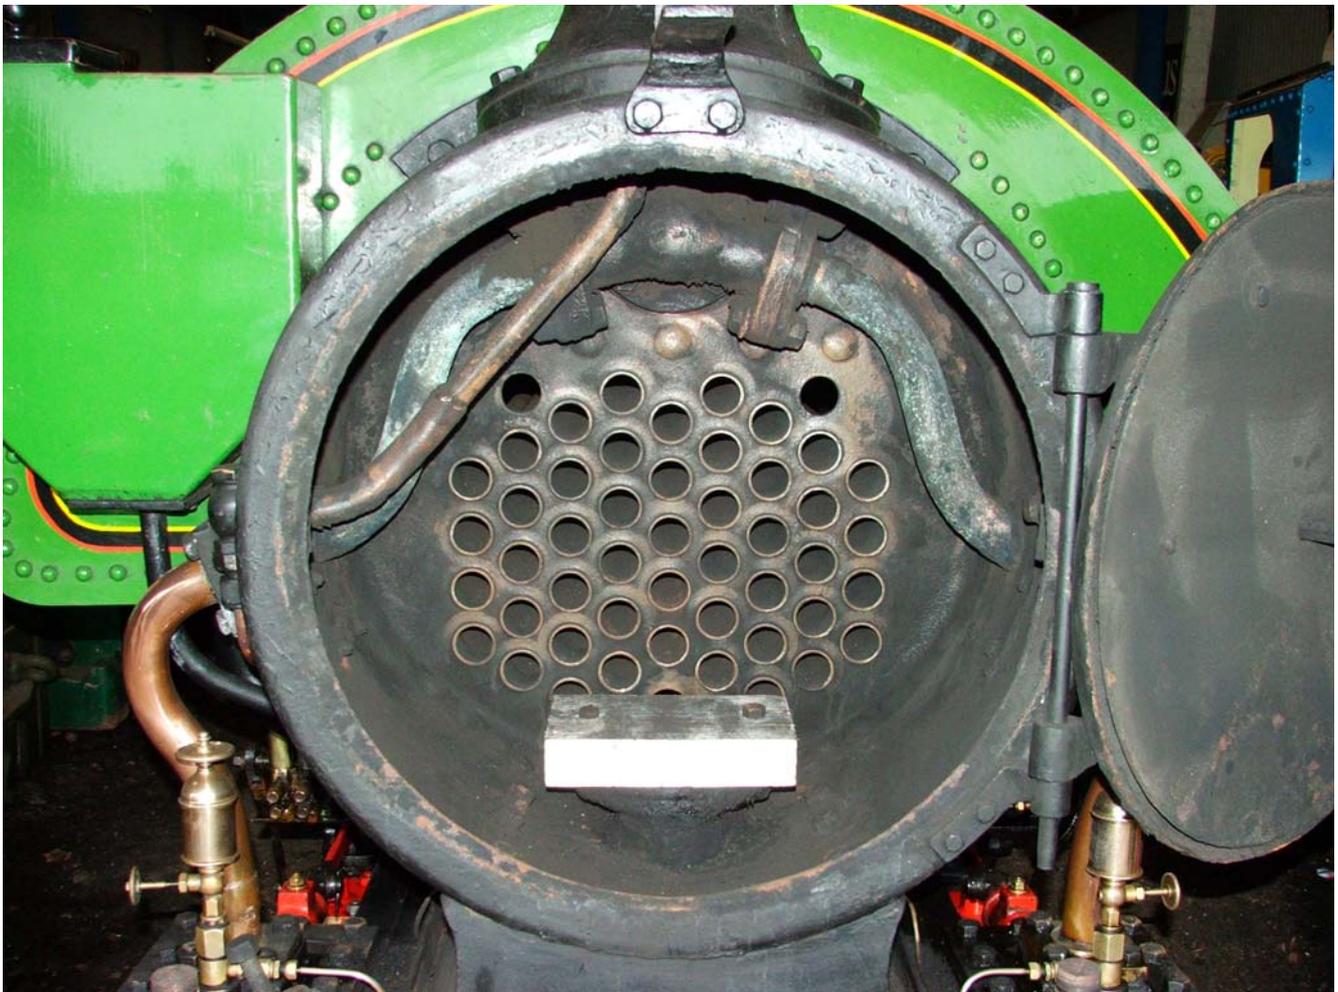
*A view not often seen by many, Isabel's smokebox, cleaned and ready for the boiler inspector     John Strike*

boiler exam by our boiler inspector. An awful lot of preparation is required including cleaning the tubes, removing carbon off the front tube plate, complete clean of firebox, removal of fusible plug and a dose of oil on the exposed bottom of the firebox wrapper. The inspector was appreciably happy with the condition in which he found her and passed her fit for use till the end of October 2007, subject as always to a satisfactory steam test. The Winson steam/air pump finally freed up towards the end of the Santa Specials and was fully dosed with oil.

The pump steam valve requires some attention, as it appears to constantly leak to the steam pump. A new Nabic fusible plug (£110 !!) was purchased and *Isabel* re-assembled ready for the start of the season on 25<sup>th</sup> March 2007

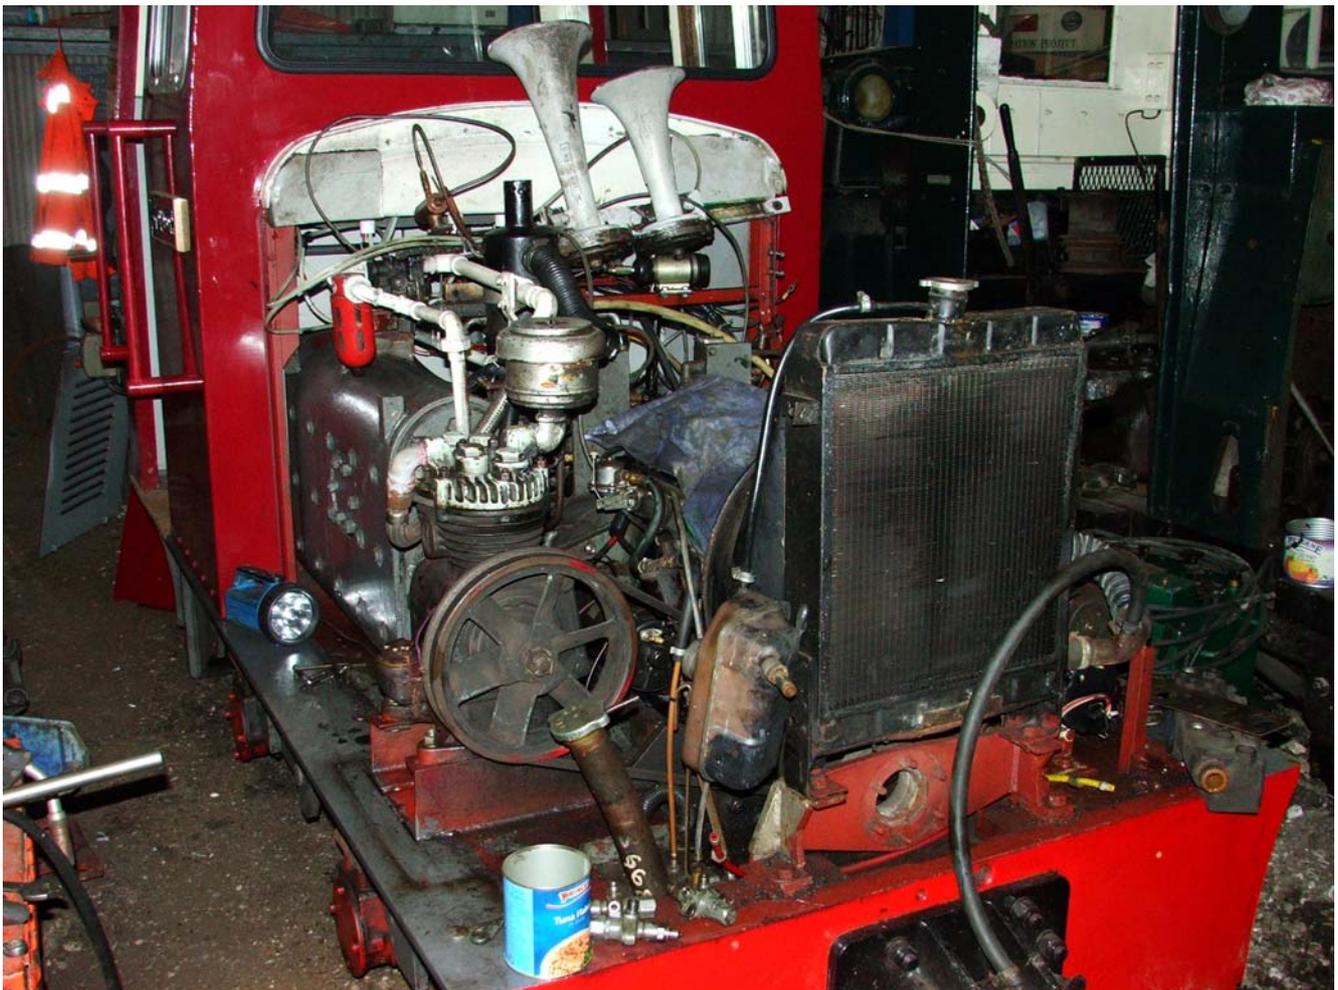
*Hunslet dismantled for overhaul*

The Hunslet *Gordon* was dismantled after the Santa's and a number of jobs started. The head was removed and sent away for testing, this didn't show up anything in particular, but we took the decision to obtain another head. The choice fell on a reconditioned bare head for £250 or a brand new head from India for £180 – we went for the Indian one! The new head and valves were fitted, the existing water-cooled manifold was discarded and Steve fabricated a new one. Steve also fabricated a simpler and smaller inlet

manifold to replace the huge Hunslet thing! A new thermostat housing was ordered as the existing one was rusted up solid. New electro-pneumatic valves have also been ordered for the transmission to replace the original faulty parts. A new main hydraulic hose from the pump has replaced the original leaky one. Finally it was test run but needs various other further modifications before it is complete. She should enter service towards the end of March in readiness for the new season.

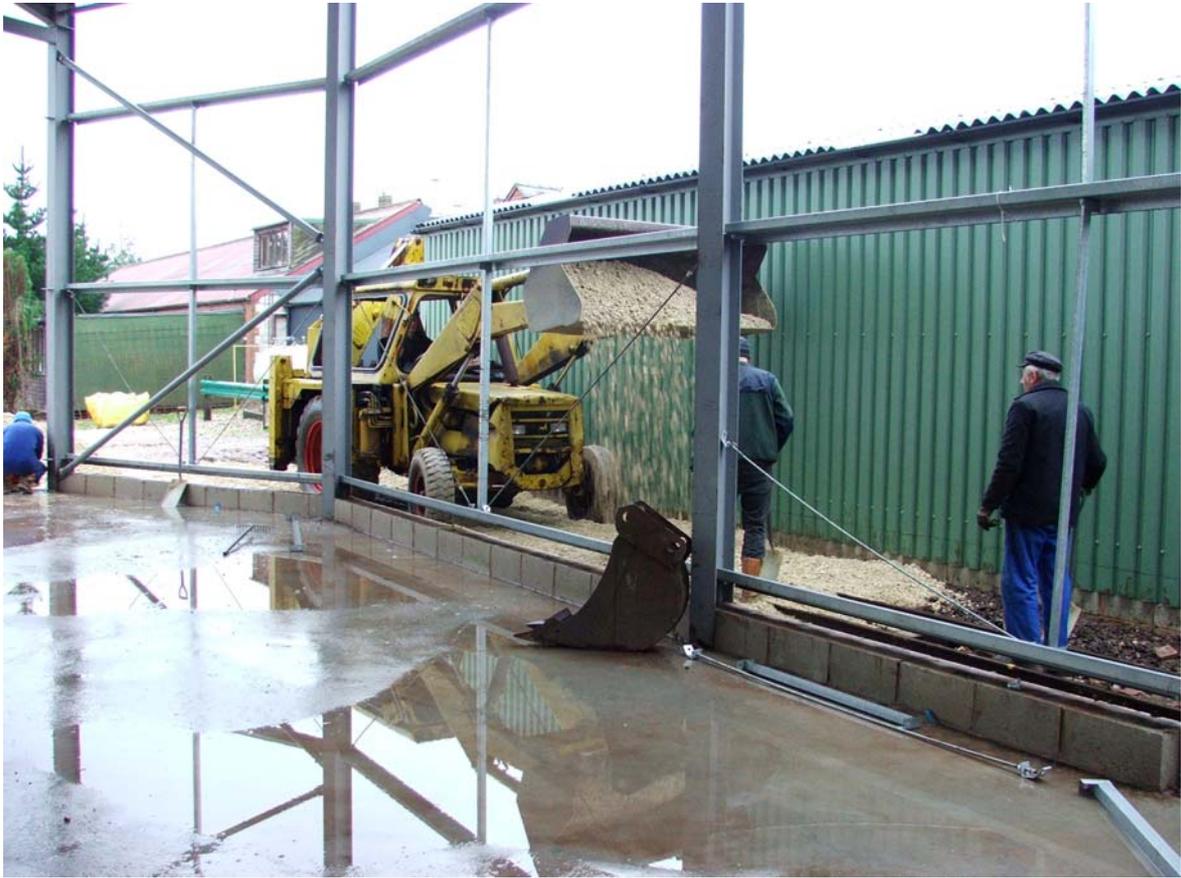
*Stoning up the siding 7 prior to the cladding*

The workshop construction has continued apace, the dwarf wall to the perimeter was laid in hollow blocks and then infilled with a mortar mix. The various cladding rails and sag rods were replaced and tensioned up as some had been removed to allow us access. The various doorframes were bolted in position and a new frame made for the personnel door for the new thin end door. 34t of crusher run was laid down siding 7

(alongside carriage shed) to create a level access for the cherry picker. An area in front of the thin end roller shutter door was also laid flush with the railhead. The cladders returned to fix all the vertical cladding, flashings and rain water goods, which took about a week. In the meantime we erected the steel for the mezzanine floor, but decided we had designed it a little too high, so we got the cladders to modify it and drop the floor level by 500mm. The rainwater down pipe got modified by a load on a wagon (!) so we changed the downspout with the fittings we had, and we now need to complete the work. The insulated doors have been ordered for the rail access and vehicle access together with 4 personnel doors, including one to replace the existing timber door to the old shed. These are all multipoint locking, steel security doors and are pretty expensive, but we only want to do the doors once! We measured and ordered a set of steel stairs, which arrived quite quickly, but unfortunately were wrong and badly made to boot, so we had to remake the entire assembly, moving all the treads and making a complete new top flight. 9” x 2” floor timbers have been placed in the centre bay of the mezzanine, we have also started the partition at the foot of the stairs.

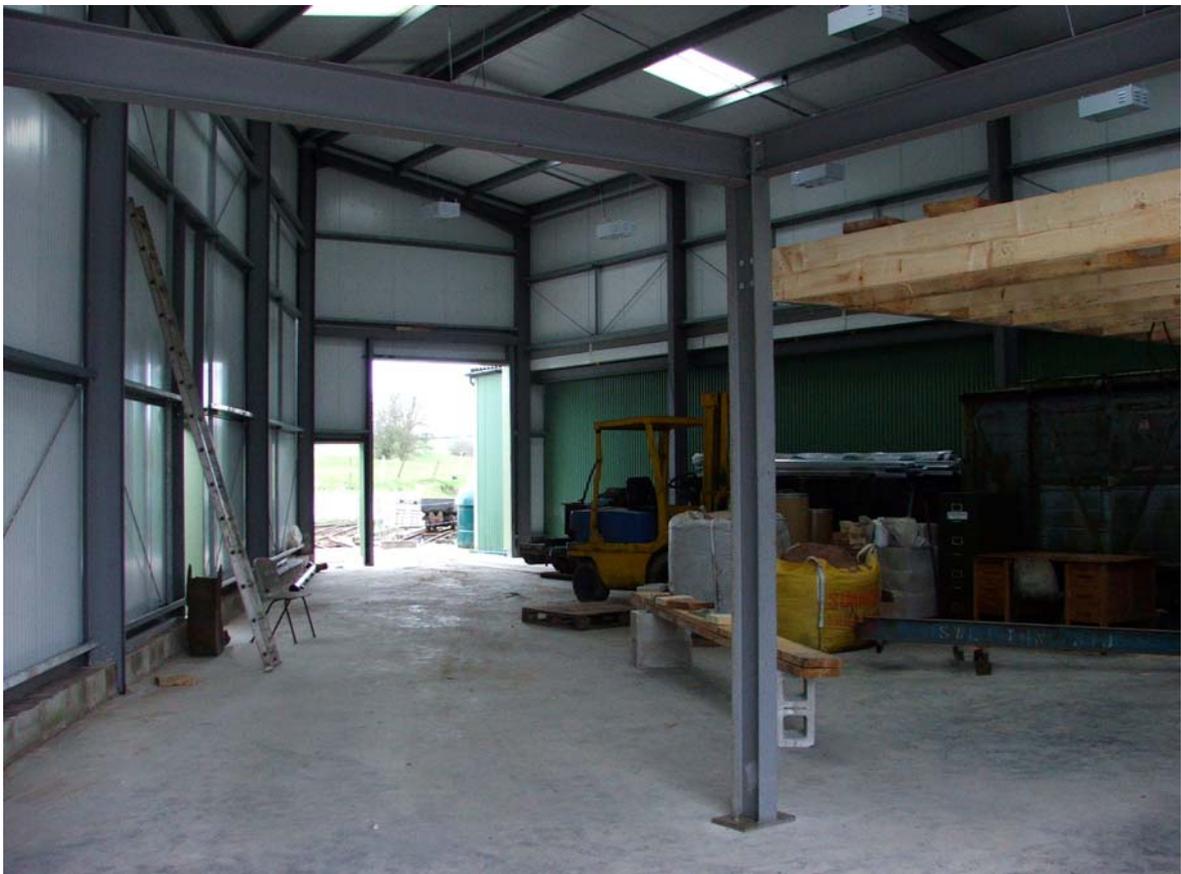
*The inside showing the end of the mezzanine floor*

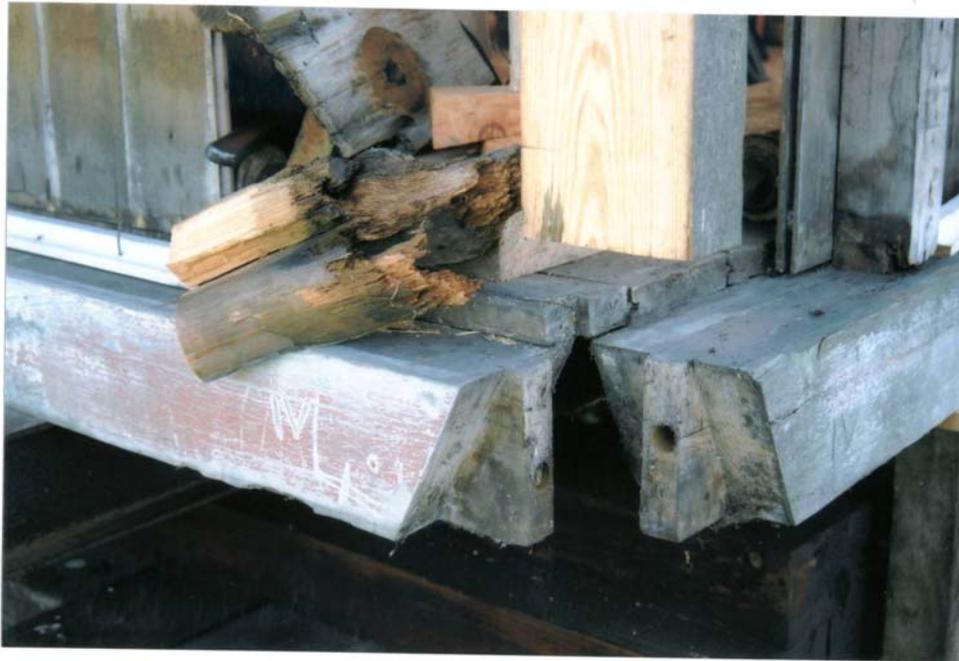
*Jointing detail of leg number three, note the excellent condition of the tenons*

The electrical gang hung all 7 low bay lights, which made the workshop very bright indeed, and John Jones has been erecting the containment round the perimeter of the shed at high level. Lol has started distributing 110v power to the existing shed to prevent frequent use of those heavy transformers. The porch to the signal box has been carefully dismantled and labelled up to enable access to the fourth and final leg, which is now being replaced.

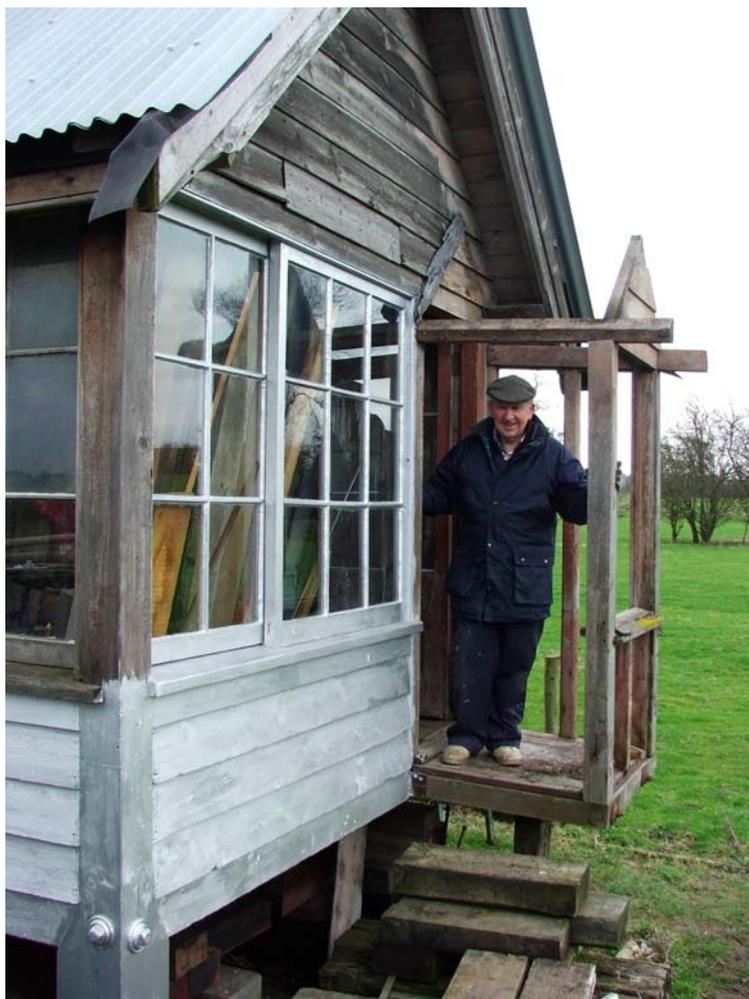
*Ray during the careful dismantling of the porch*
